Shore ice ride-up and pile-up features

Part II: Alaska's Beaufort Sea coast—1983 and 1984

CRREL Report 84-26

Austin Kovacs

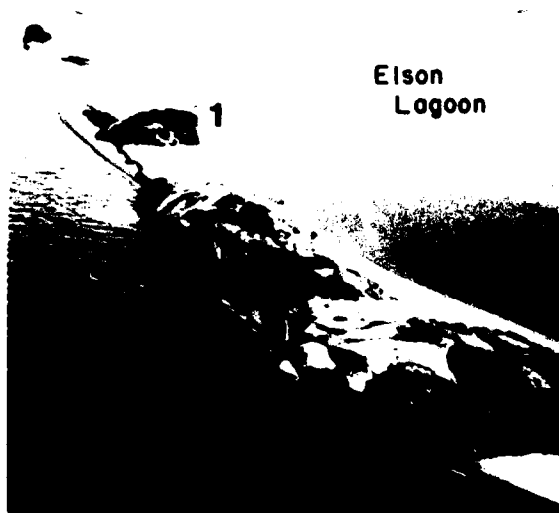
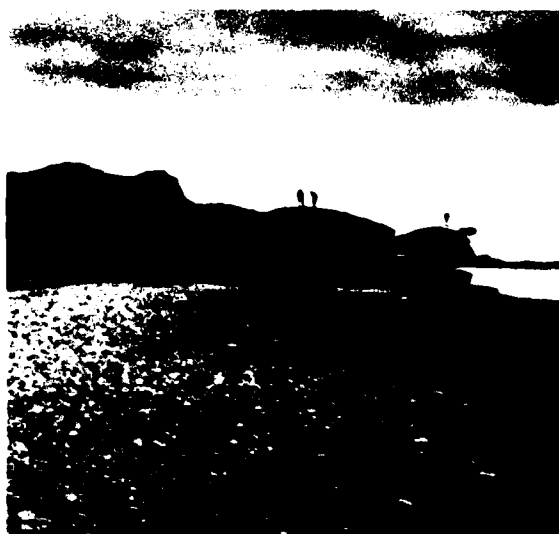
Figure 2. Aerial (a) and ground (b, c and d) views of ice pile-up remains on Igalik Island, August 1982.

a. The island in the background is Kulgurak Island, which is seen to have an ice pile-up remaining at the northwest corner.

b. The back side of the ice pile-up (1) showing the wave-undermined ice extending out over the waters of Elson Lagoon. Note the general lack of ice block detail and absence of voids in the ice face.

c. The back (lagoon) side of the largest of the ice pile-up remains. Note that most of the ice is covered with sandy gravel.

d. A side view of the far end of the large ice pile-up. The internal block structure and sediment are visible, as is one portion of an ice sheet which had buckled into a convex shape, as outlined by the dotted line.

high and it consisted of ice blocks 0.55 m thick. The pile-up as it appeared in August 1982 is shown in Figure 2. At this time the remaining ice was up to 5½ m high, and in places it was covered with a layer of sediment brought ashore by ice which had gouged into the sea floor. An aerial view of the ice formations remaining on 25 May 1983 is shown in Figure 3. Arrow 1 points to ice pile no. 1 shown in Figure 2. This pile was still about 4 m high. The ice blocks at the base of this formation (Fig. 3) are from the breakup of the cantilevered portion of the ice shown in Figure 2. Much of the remaining ice was found covered with seabed sediment up to 0.20 m thick, and the underlying ice structure was discolored by similar debris (Fig. 4). Sea ice movement onto the land thus helps to restore the beach with material eroded by waves and current processes.

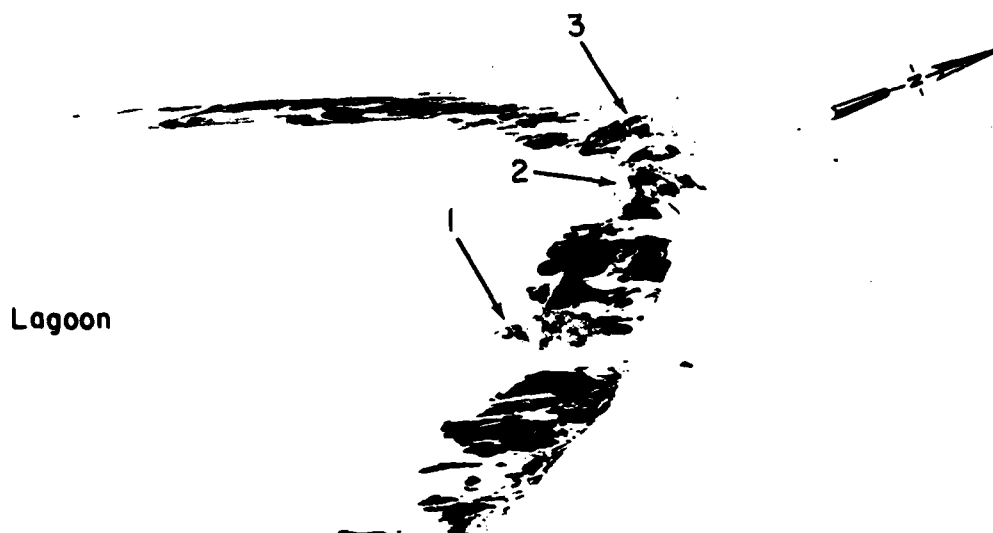
Figure 3. Remains of shore ice pile-up (1, 2 and 3) on Igalik Island in May 1983.

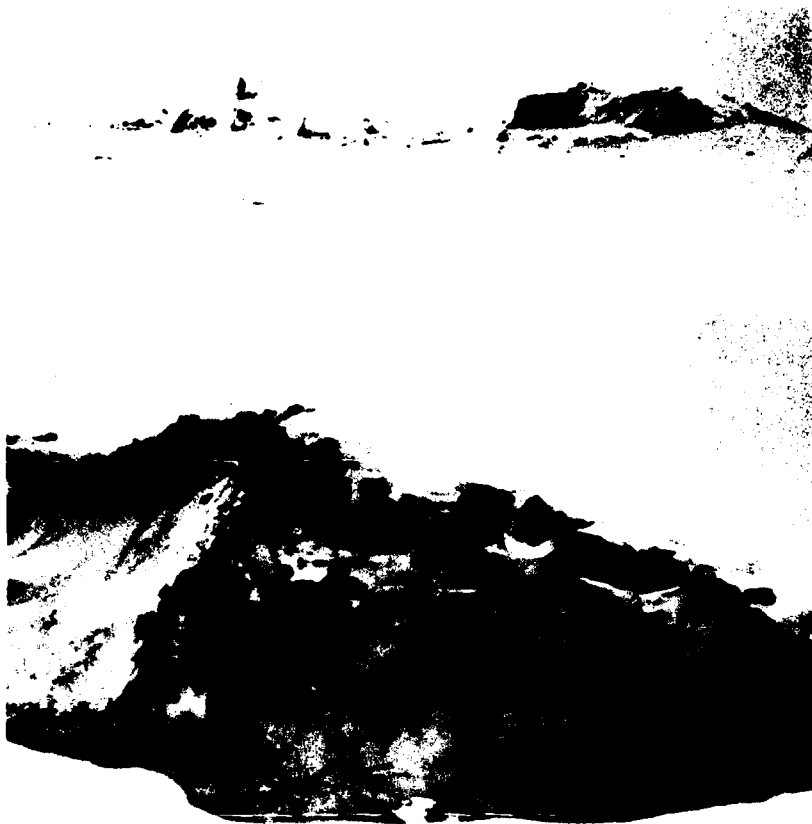
Figure 4. Debris-covered ice, Igalik Island.

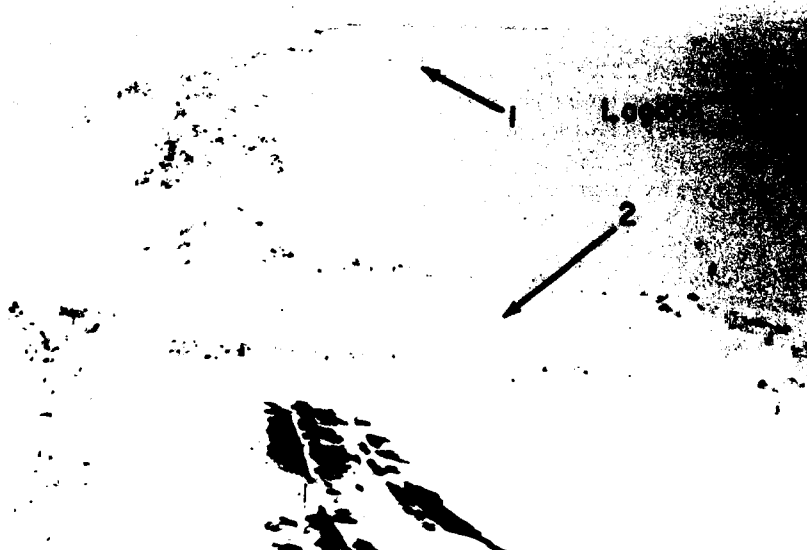
Figure 5. Shore ice pile-up and two ice overrides on barrier island at position E in Figure A1.

The mainland can be seen a short distance beyond site 1 in Figure 5. Along ½ km of this coast, ½-m-thick sea ice was found piled up to 5 m high and 30 m inland on the 2- to 3-m-high coastal bluff.

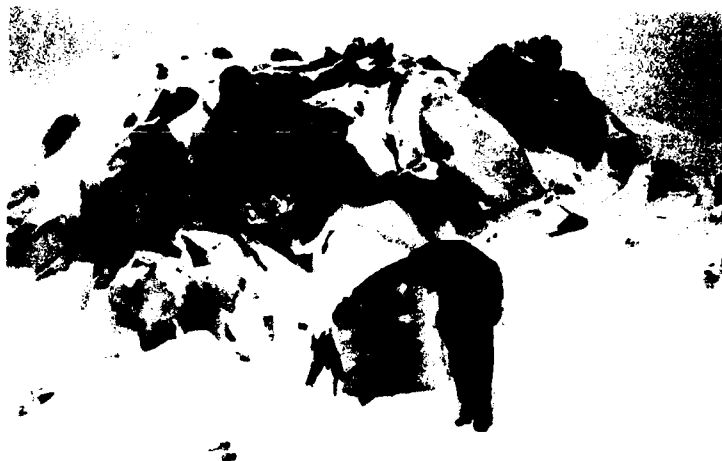
Figure 8. Sea ice blocks in pile-up on Spy Island.

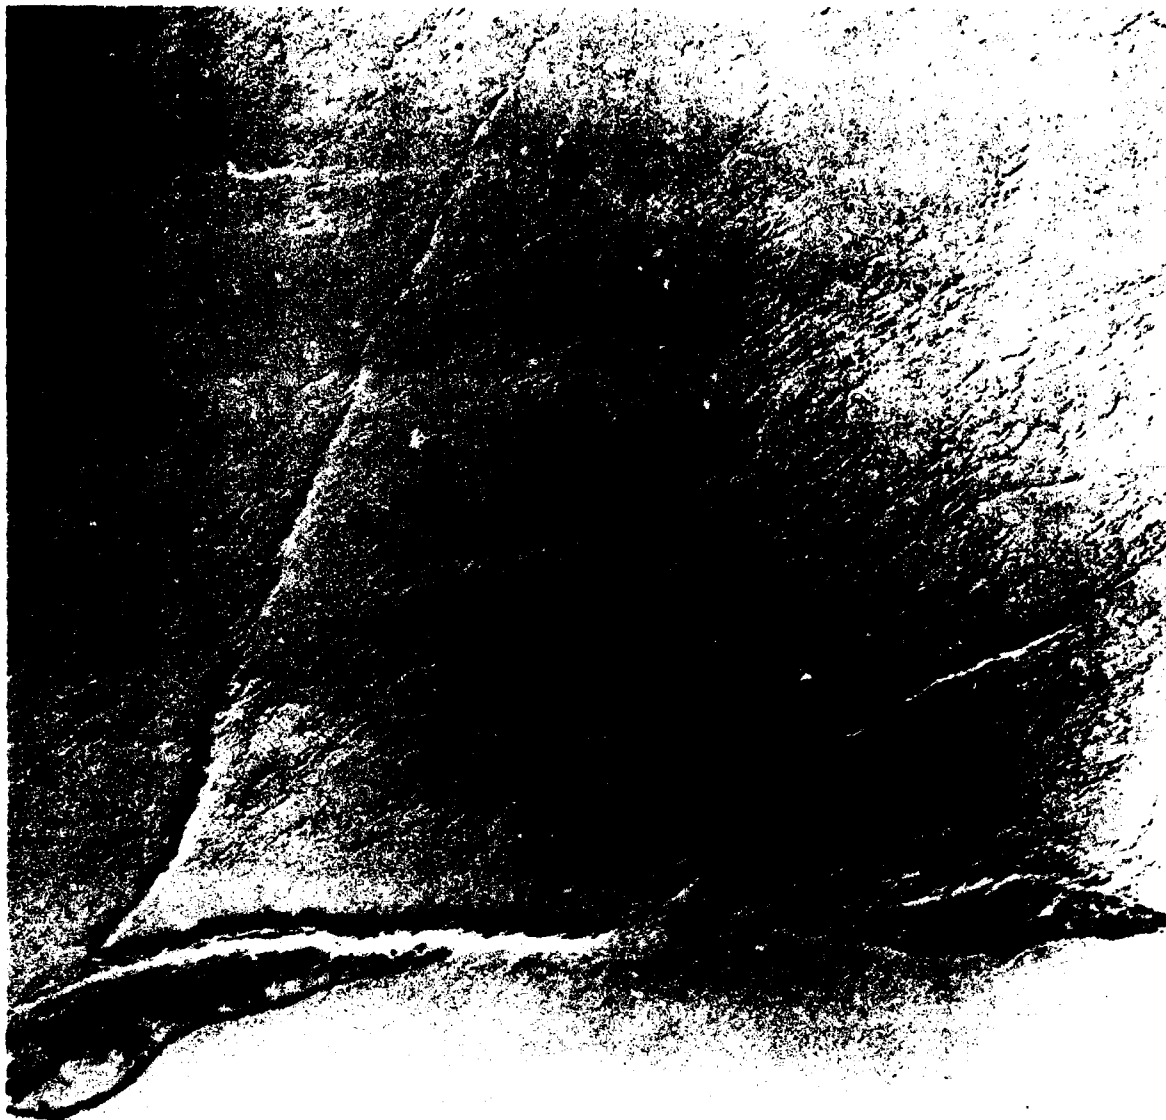
Figure 9. Aerial photo of shore ice pile-up on Spy Island, 22 March 1983 (photography by Air Photo Tech).

The large grounded shear ridge, which extended northward from the west end of the shore ice pile-up as seen in Figure 9, was still in place in July as

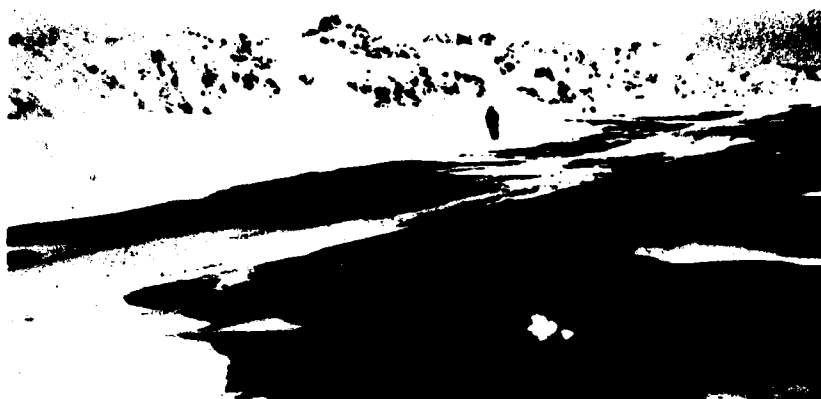
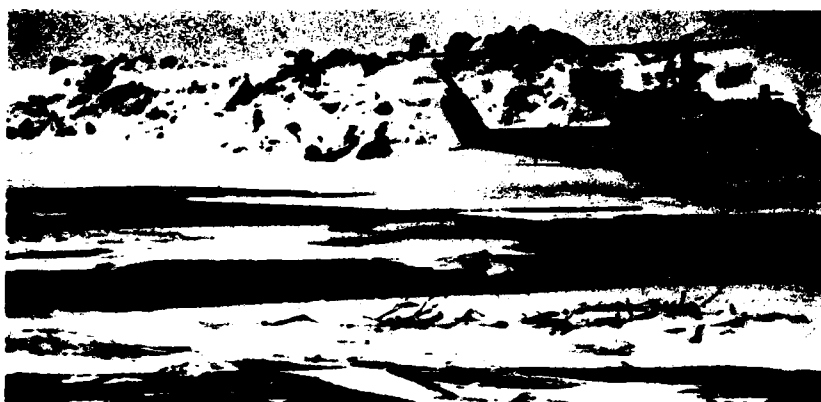
Figure 10. Ground views of shore ice pile-up on Spy Island. Note sediment incorporated in the ice rubble.

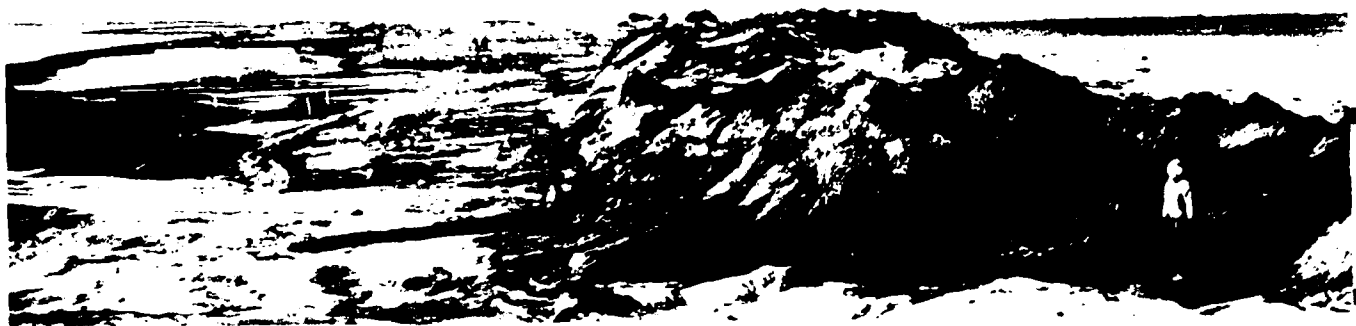
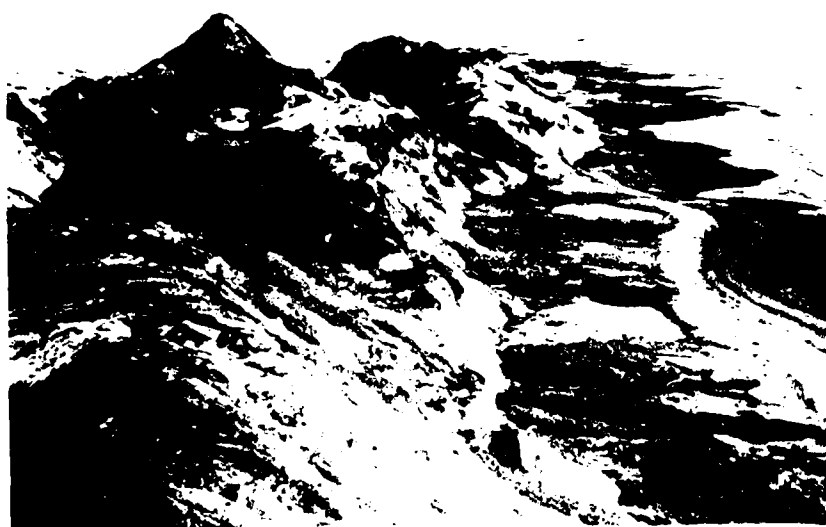
Figure 14. Shore ice pile-up on east end of Spy Island.

thick near the toe of the ice formation. At the end of July 1983, portions of the shore ice pile-up were still over 6 m high (Fig. 14).*

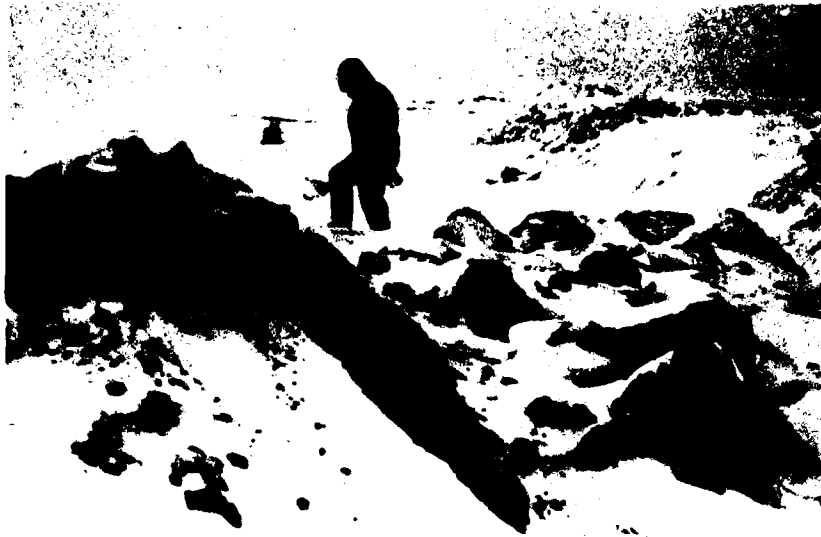
Figure 16. Pingok Island shore ice pile-up. Note offshore sediment incorporated into the ice rubble.

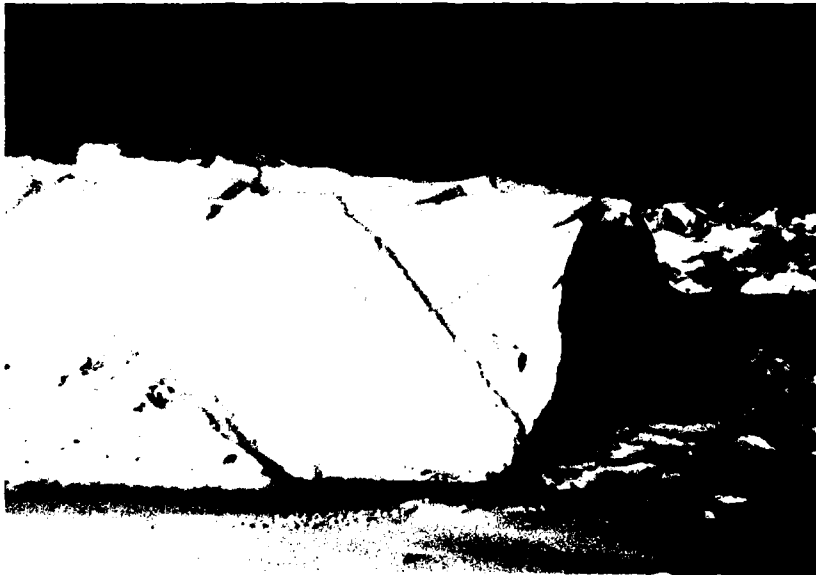
Figure 18. Buckled ice sheet.

runway is about 38 m. Offshore we saw where the 1-m-thick sea ice had been buckled upward (Fig. 18). The uplifted ice sheet surface was found to be laced with 0.15- to 0.2-m-deep secondary fractures which extended away from the primary hinge fracture. At this depth there was another fracture plane which paralleled the ice surface (Fig. 19). This fracture occurred at the transition between the isotropic granular ice and the lower columnar ice layers. Under stress the two ice layers, having different "elastic" properties, were not strain-compatible and separated. Apparently, the far-field forces which formed the shore ice pile-up were concentrated at this site and buckled the ice sheet. The localized stress needed to buckle the ice sheet can be estimated from the equation:

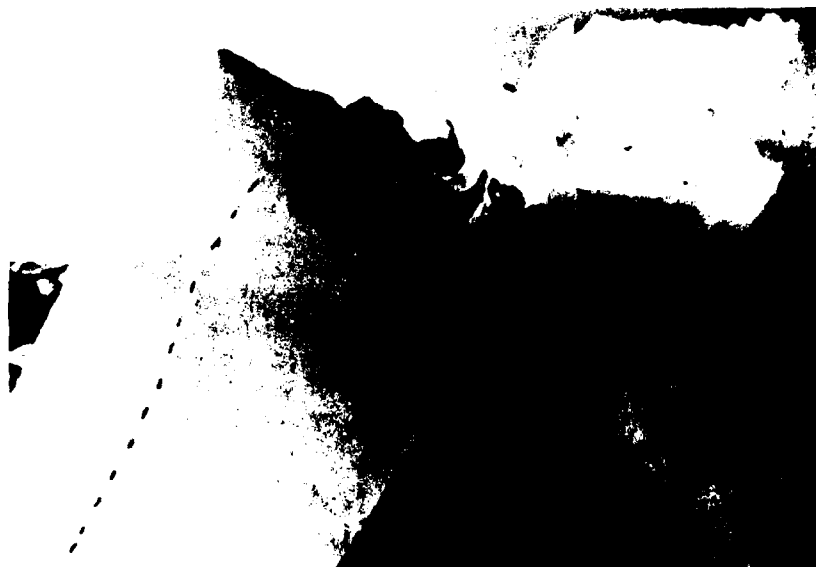
Figure 19. Internal fracture surface (dashed line).

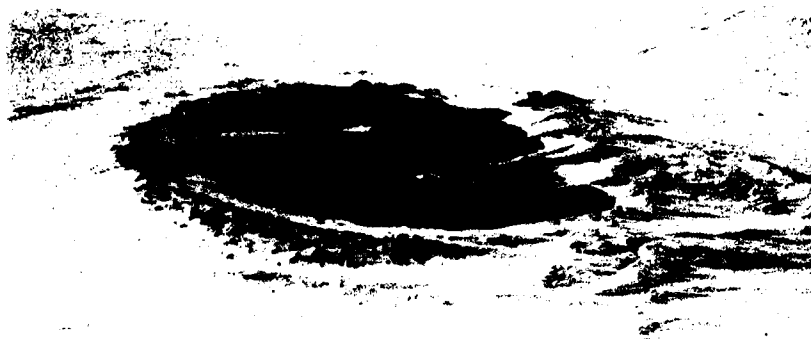
Figure 21. Ice ride-up rubble on man-made gravel exploration island.

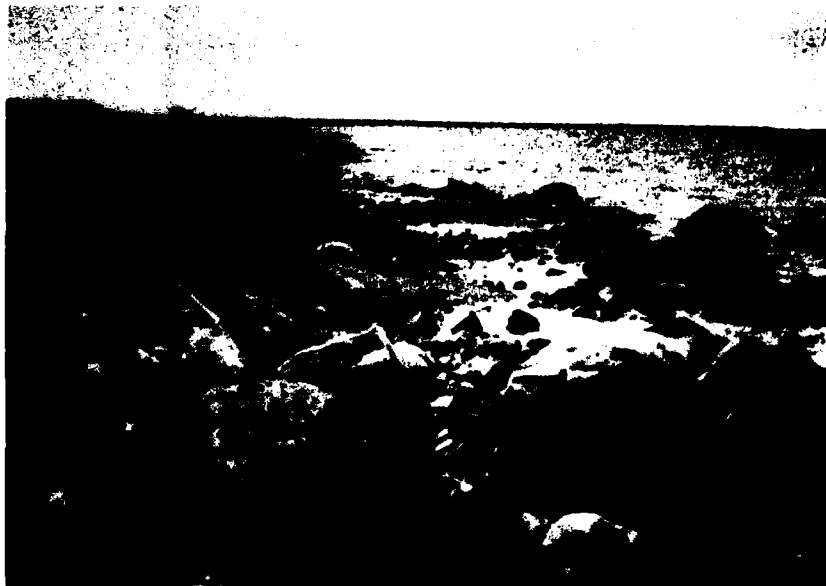
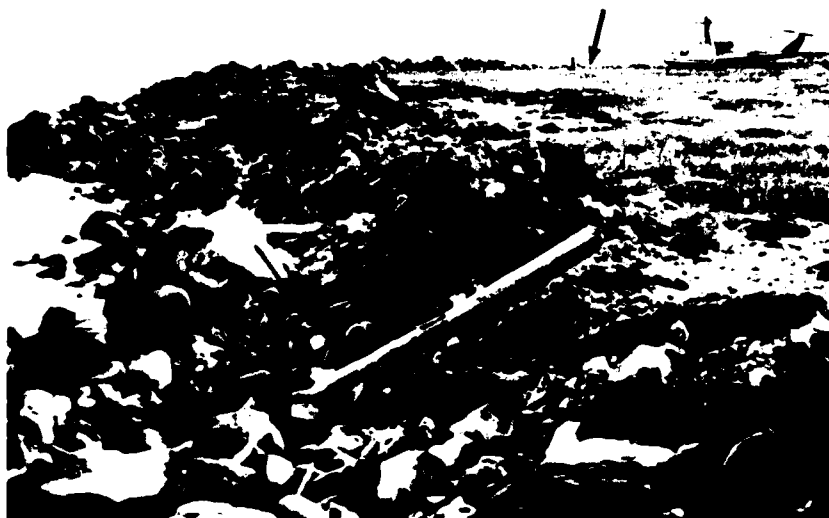
Figure 24. Boulder coast, 1982.

*a. Western end of bluff.
Note the offshore boulders
and the limited number of
boulders resting along the
edge of the bluff.*

*b. View of the boulder
rampart on top of the
eastern end of the bluff.
Arrow points to driftwood
log.*

line consisted of boulders scattered randomly along the edge of the 1½-m-high bluff and a "beach" area as shown in Figure 24. A gradual rearranging of the boulders by ice-push and the receding of the bluff through erosion had occurred over these years. However, the transformation that occurred during the 1983 spring breakup was

with a similar one taken in 1982 as shown in Figure 24b. The former shows that the boulder ridge along the edge of the bluff had increased in height and that the tundra surface was gouged, allowing water to pool in the depressions. In places, the tundra mat was folded back (Fig. 27) and large

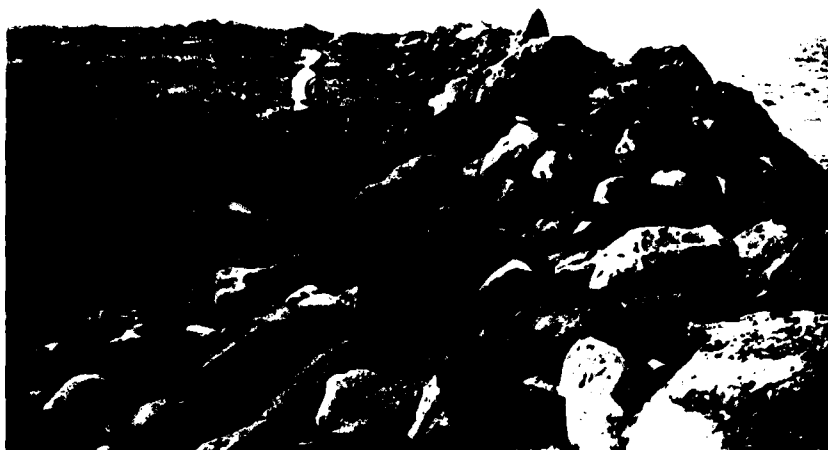
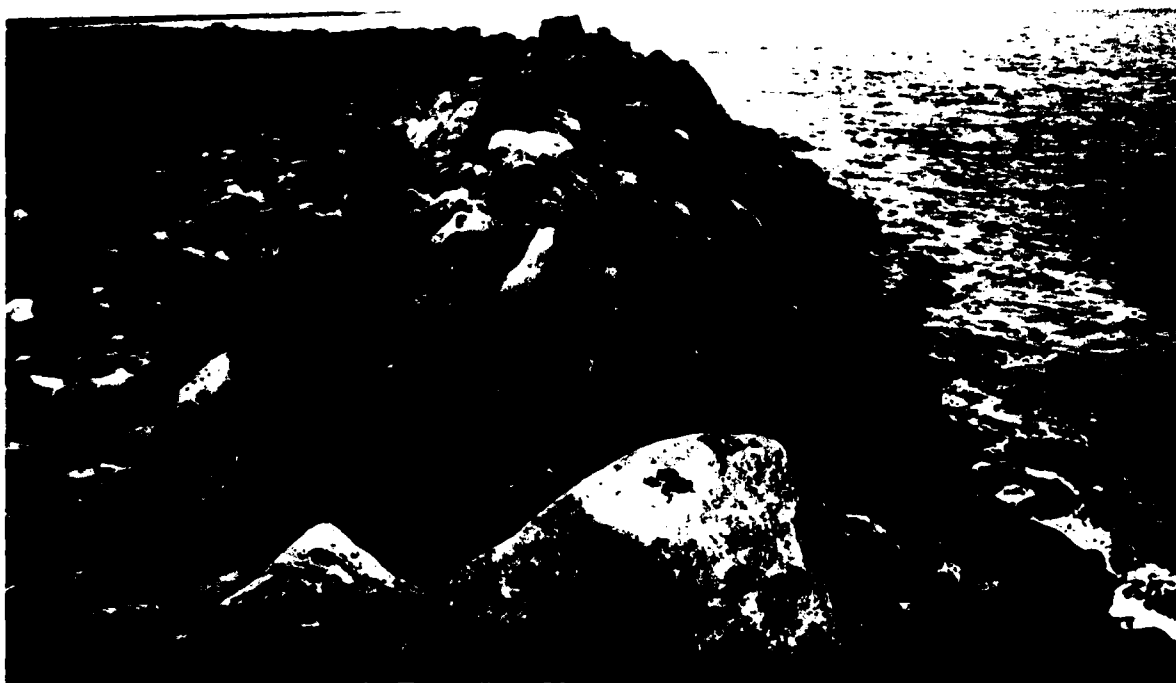
Figure 25. Western end of boulder coast rampart.

a. 1983.

b. 1979 (photograph courtesy of P. Barnes).

significant. On the western end of the bluff, a boulder ridge 1 to 2 m high now existed. As viewed from the east, this section of the bluff is shown in Figure 25a, and for comparison a 1979 view of the same bluff area is shown in Figure 25b. The boulder-littered shore as seen from the west end is shown in Figure 26. This view may be compared

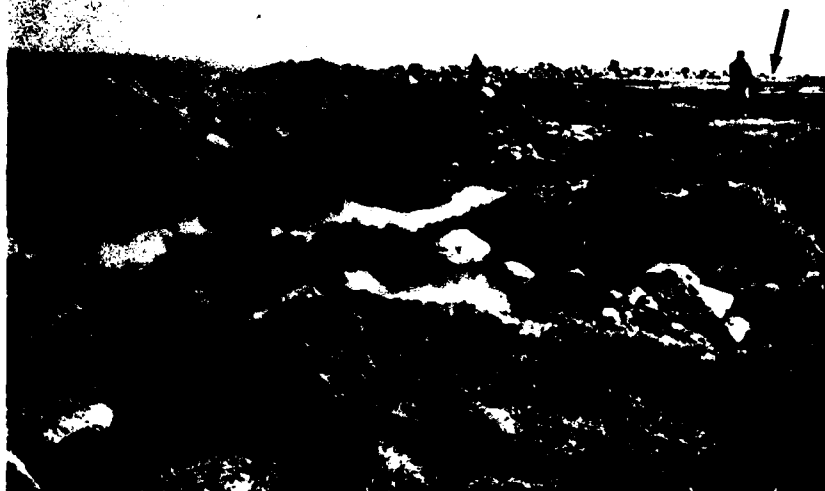
Figure 26. Boulder rampart on east end of coastal bluff. Arrow points to same driftwood log as in Figure 24b.

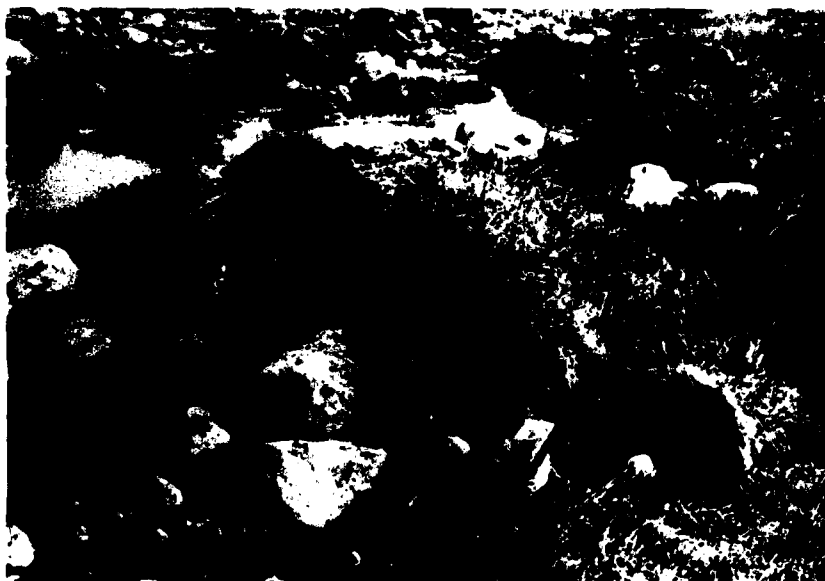
Figure 27. Ice-pushed tundra and boulder debris.

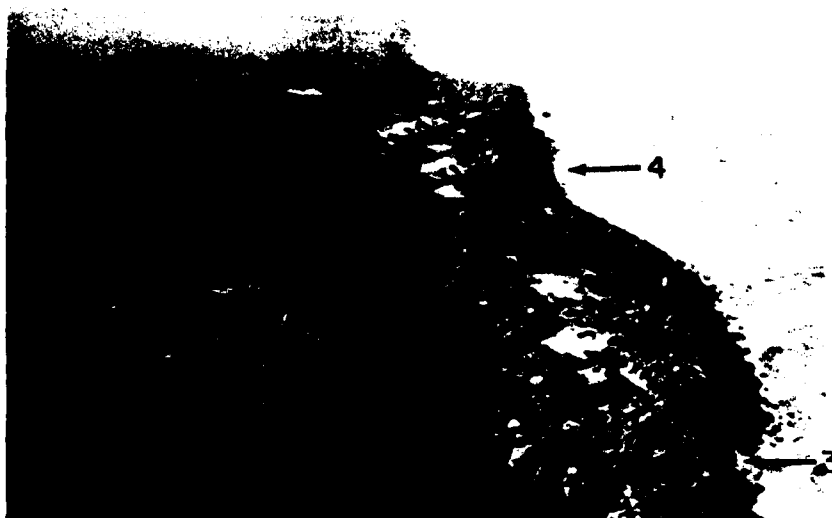
Figure 28. Ice-scarred tundra, west end of boulder coast. Arrows point to two of the many boulders which were driven into the tundra mat.

boulders were driven into this material (Fig. 28). An aerial view of the west end of the boulder coast is given in Figure 29. Arrows 1 and 2 indicate the two boulders marked in Figure 28. Figure 29 also shows that there is no longer a "beach" area as seen in Figure 24, and that the seaward face of the

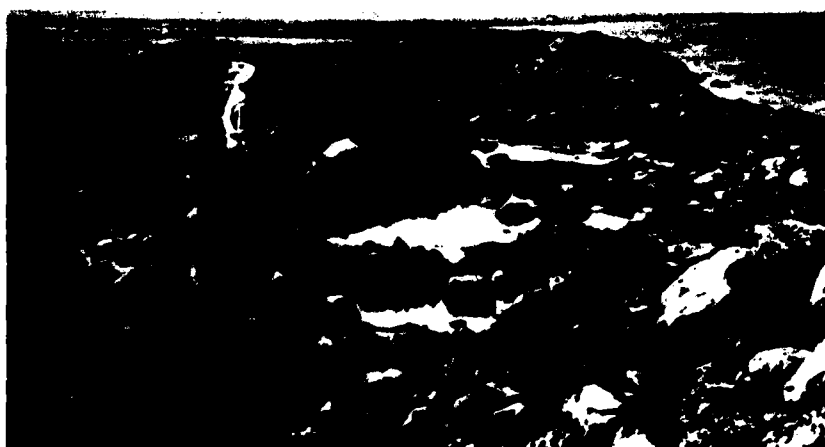
Figure 29. West end of boulder coast. The vertical arrow points to the inland limit of ice-transported debris.

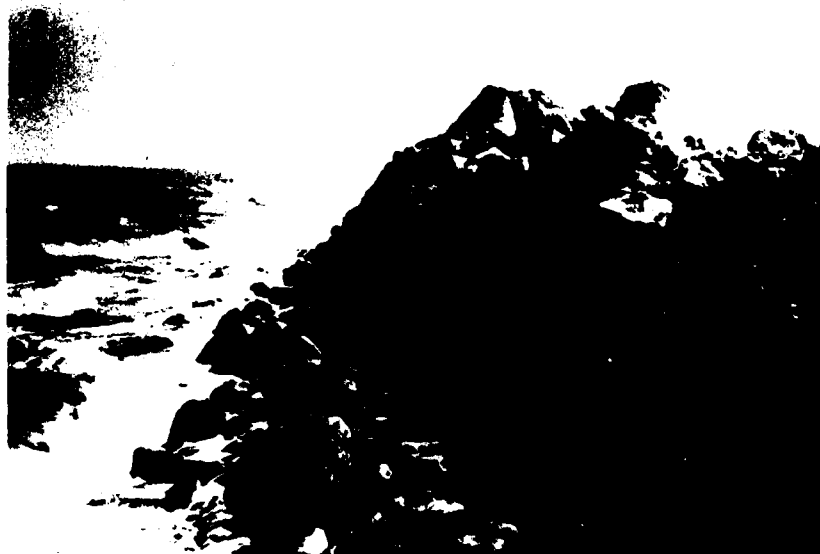
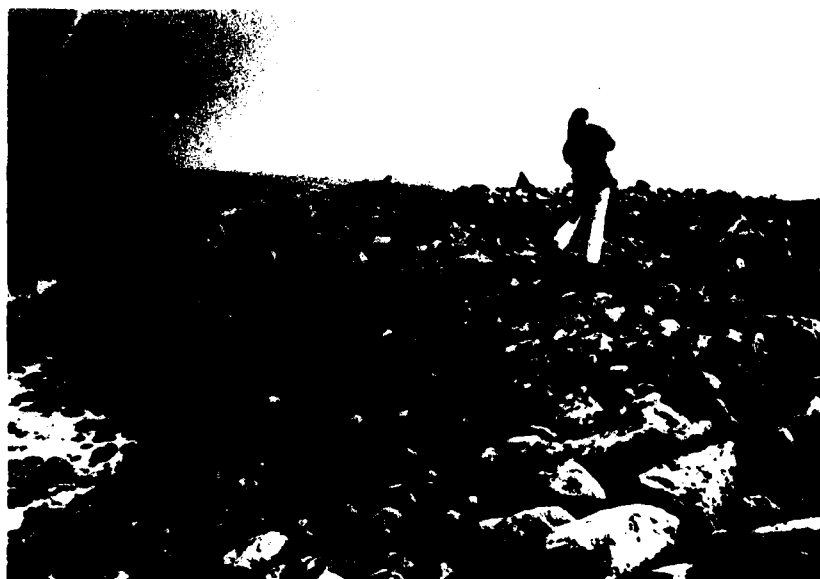
Figure 30. Boulder coast morphology.

boulder rampart is either quite steep (arrow 3, see Fig. 30a) or has been rearranged to form a boulder pavement (arrow 4, see Fig. 30b). The changes that occurred between the summers of 1982 and 1983 at the east end of the boulder coast are shown in Figure 31.

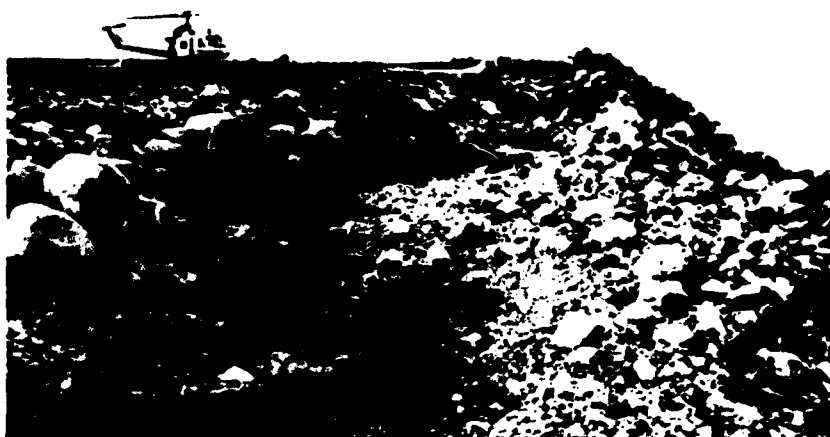
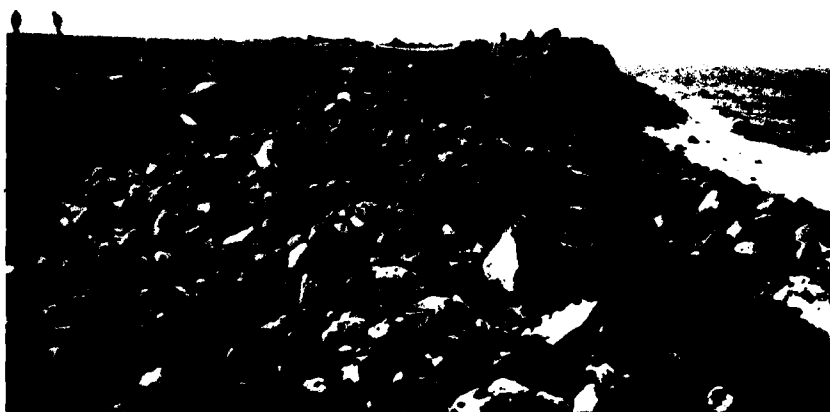
Figure 31. East end of boulder coast in (a) 1982 and (b) 1983.

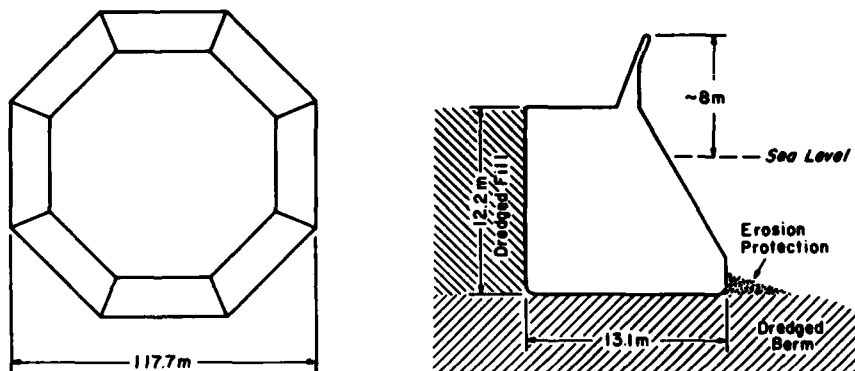
Figure 37. Kadluk concrete caisson-retained island structure.

kenzie Bay, Canada. The structure's wall cross section is shown in Figure 37 and a view of the island from the ice is shown in Figure 38. The top of the ice-wave deflector is about 8 m above the sea. During the first week of January 1984, 1-m-thick sea ice was driven against the structure, forming the grounded rubble formation shown in Figure 39. During the ice-piling event, several tons of sea ice overtopped the deflector and fell upon the concrete "floor" at location 1 in Figure 39. While no damage apparently resulted from this event, it does show that steep-sided structures like Kadluk can be overtopped by sea ice. Further refinement of the ice-wave deflector appears to be necessary to ensure that ice ride-up and overtopping of this type of structure will not occur. This will become even more important as exploratory structures are placed at locations more exposed to the dynamic movements of the arctic pack, sites

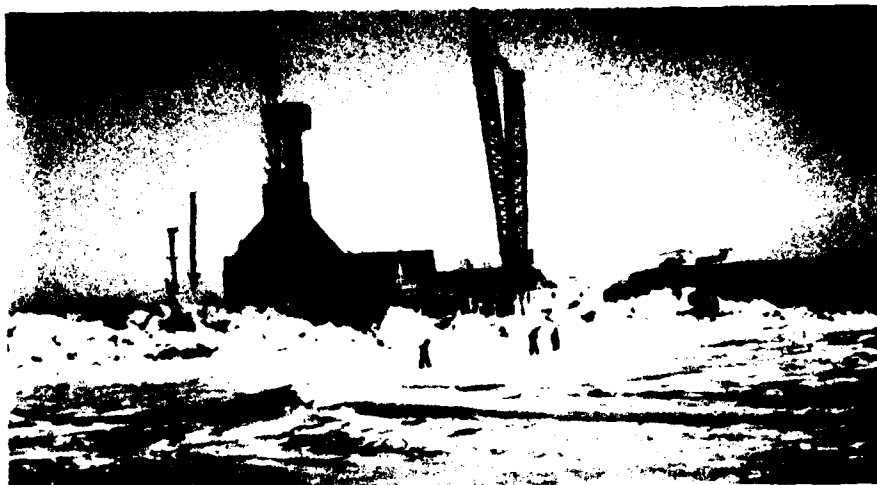
Figure 38. Kadluk Island. Arrow points to area where ice overtopped ice-wave deflector (photograph by W. Tucker).

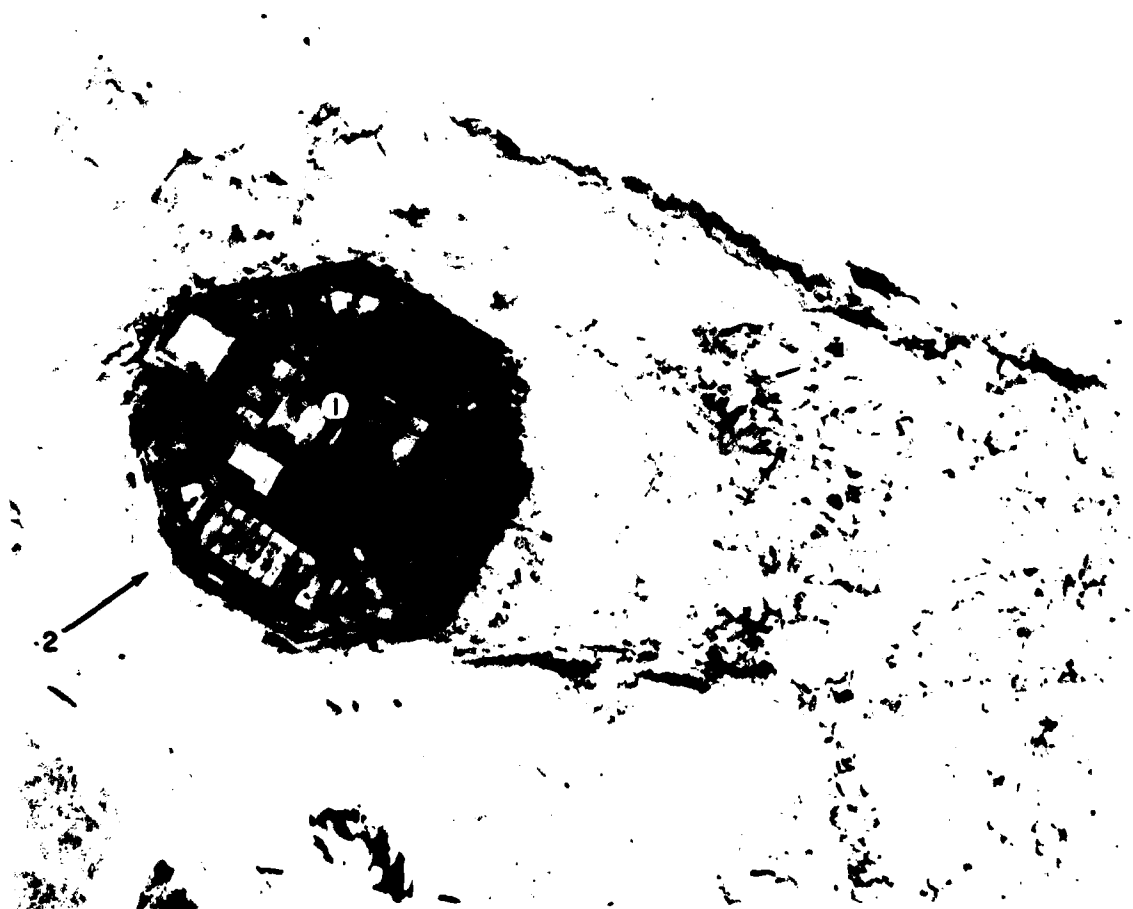
Figure 39. Ice rubble around Kadluk Island. Arrow 1 points to ice blocks on concrete surface. At arrow 2, thermal expansion of fast ice pushed both first- and multi-year sea ice vertically up the face of the caisson above the ice-wave deflector (photograph by Esso Resources Canada).

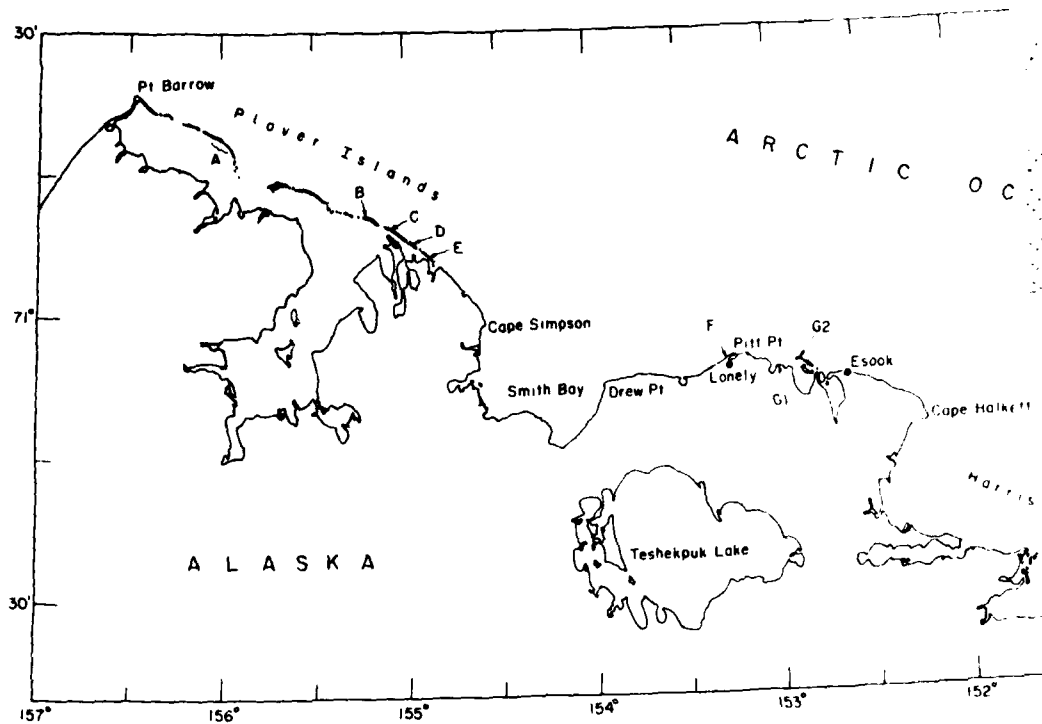
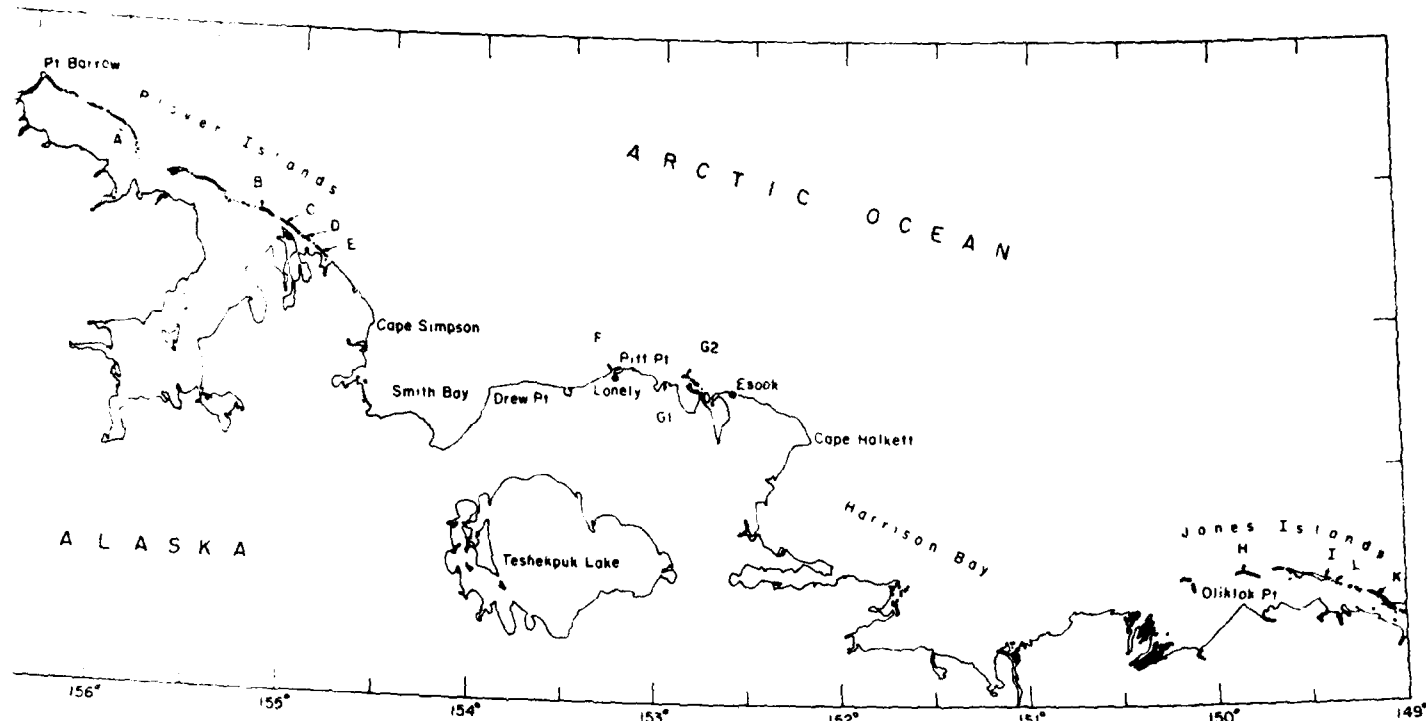
Figure A1. Western Alaska Beaufort Sea coast. Numbered arrows mark location of shore ice

Figure A1. Western Alaska Beaufort Sea coast. Numbered arrows mark location of shore ice ride-up or pile-up sites discussed in text.

The first feature observed was a shore ice pile-up on Tapkaluk Island (position A, Fig. A1). The rubble, composed of ice blocks $\frac{1}{2}$ m thick, was 3 to 4 m high and extended up to 10 m inland. Further east on Igalik Island (position B) we observed

Near the Lonely Dew Line Station (position F, Fig. A1) a shore ice pile-up was observed which reached 5 m high and extended over 8 m inland.

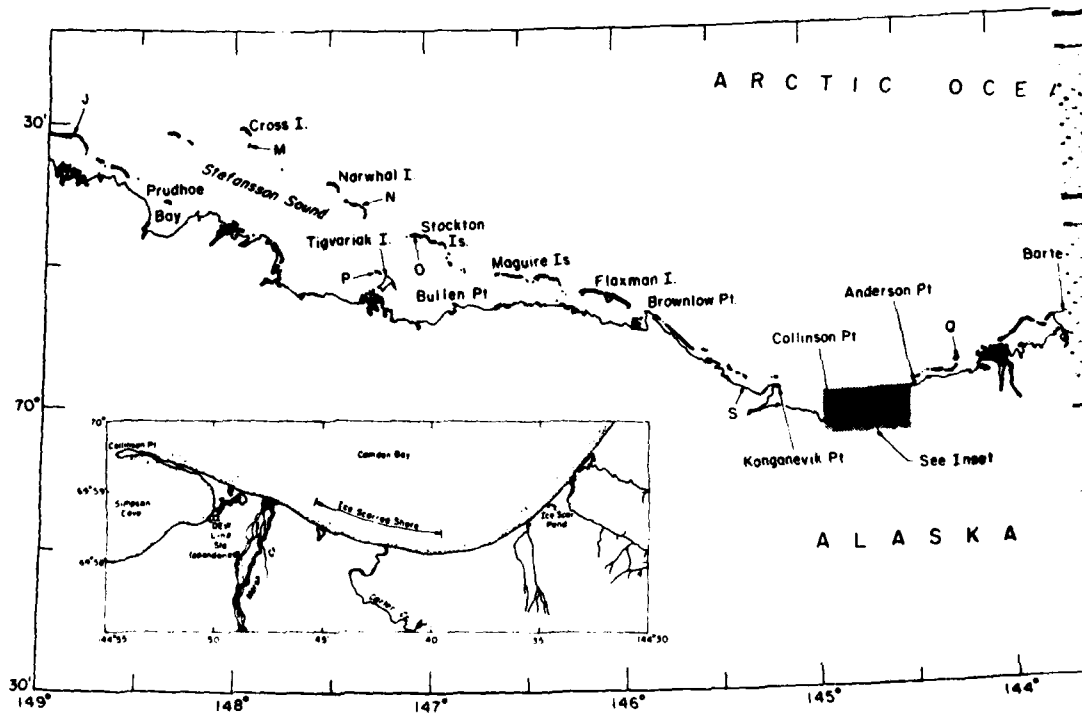
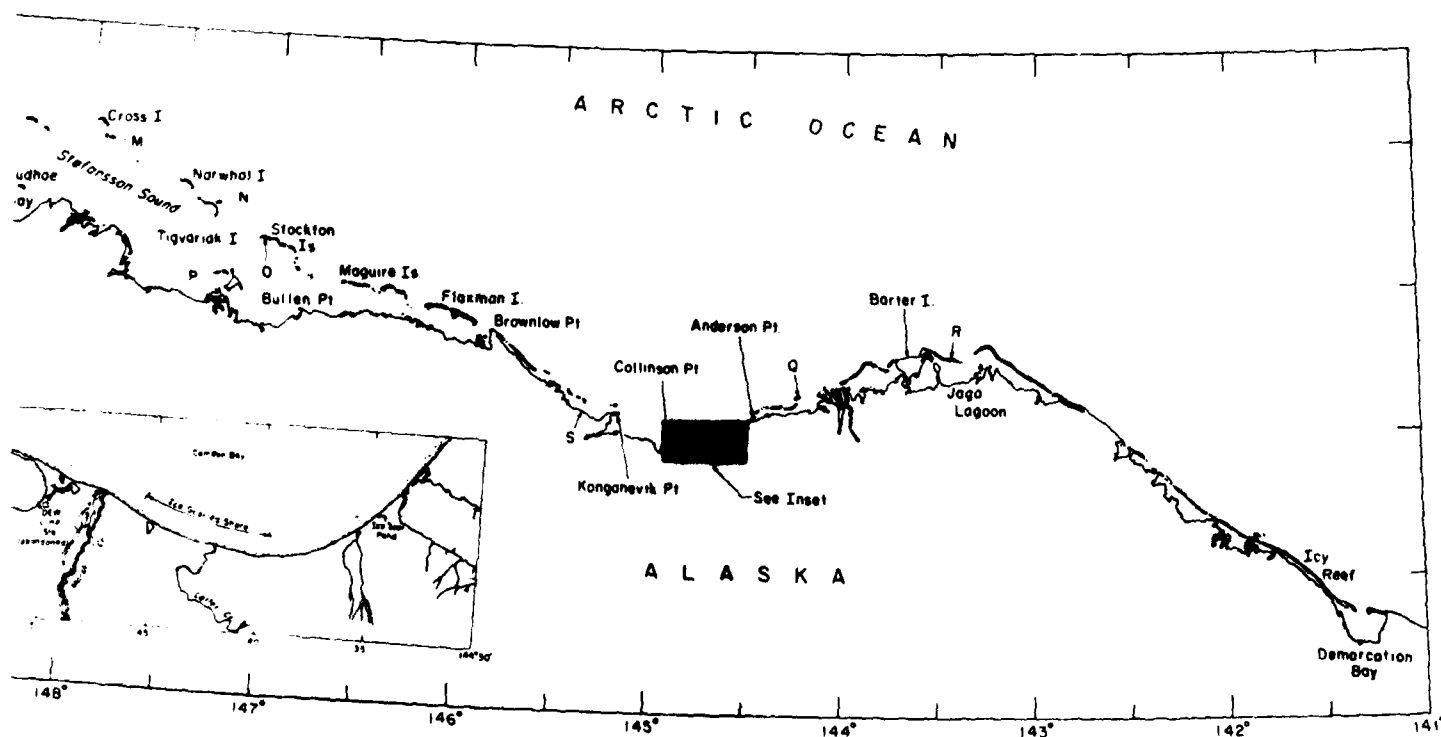
Figure A2. Eastern Alaska Beaufort Sea coast. Numbered arrows mark location of shore ice

Figure A2. Eastern Alaska Beaufort Sea coast. Numbered arrows mark location of shore ice ride-up or pile-up sites discussed in text.
